Navajo Abandoned Uranium Mine

Site Screen Report

Jack Daniels No. 3 AUM Site

Navajo AUM Western Region

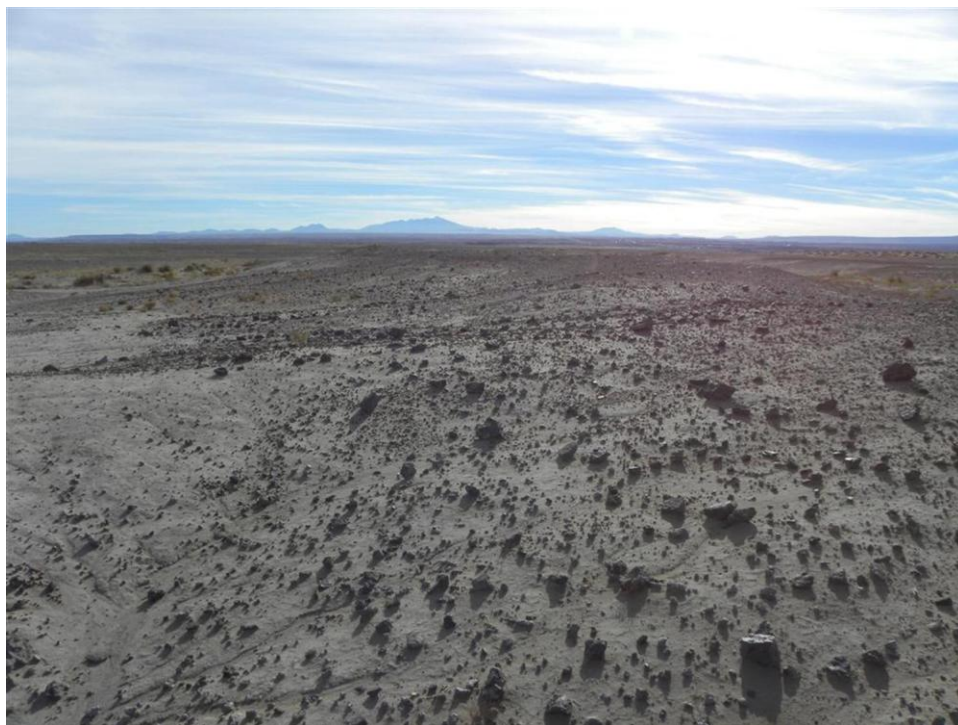
Photo 1. Jack Daniels No. 3 mine site
